## **Einde levensduur damwanden**

Evaluation of the measurement uncertainty of  
Pulsed Eddy Current Testing (PECT) for  
measuring the residual thickness of sheet pile  
walls

# **Evaluation of the measurement uncertainty of Pulsed Eddy Current Testing (PECT) for measuring the residual thickness of sheet pile walls**

TNO 2025 R10763 – 30 July 2025  
Evaluation of the measurement uncertainty of  
Pulsed Eddy Current Testing (PECT) for  
measuring the residual thickness of sheet pile  
walls

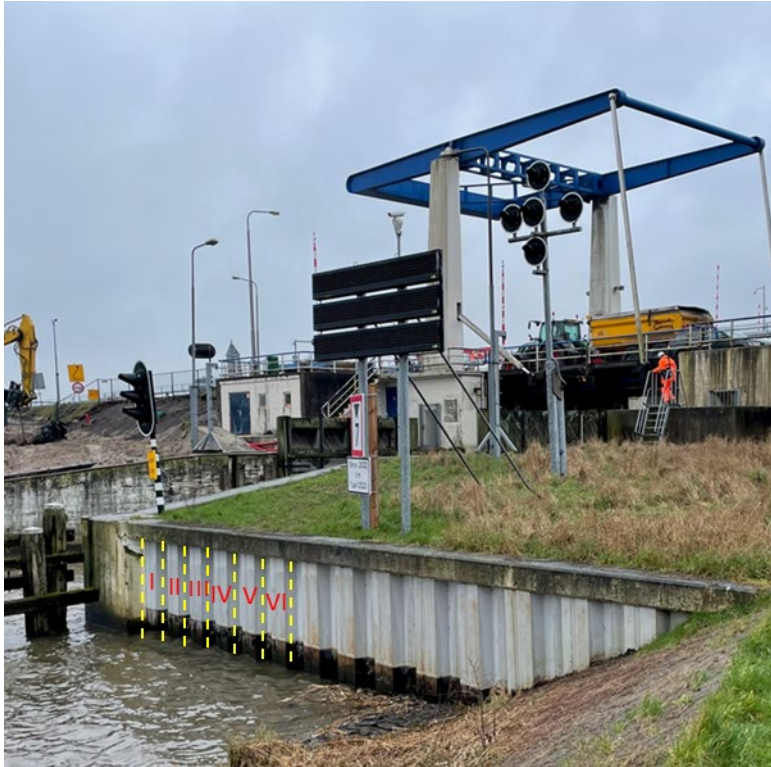
Figure 2.2: Sheet pile profiles used in this investigation.

The twelve sheet pile profiles used in this investigation were pulled out in 2023 from the Roggebot lock, that was located in the municipality of Dronten between the Drontermeer and de Vossemeer. The location of the sheet piles is shown in [Figure 2.1](#) and [Figure 2.2](#).

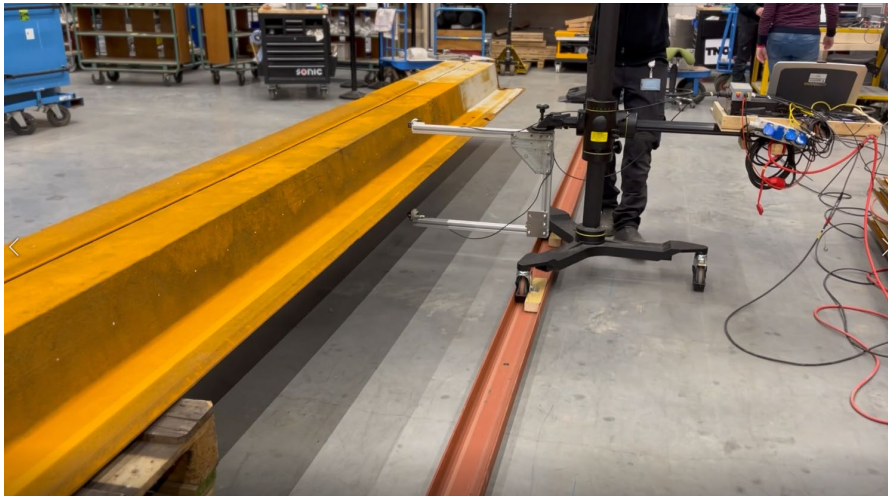
The measurement setup consists of two lasers and one wire transducer connected to a data acquisition system. The two lasers sensors are mounted on a frame, one below and one above the sheet pile, as shown in [Figure 2.3](#). In this way, the distance between the top and bottom of the section is measured in relation to the same reference point. The residual thickness is then obtained as the difference between the two measurements. At the same time, the distance between each measurement point and the beginning of the sheet pile profile is measured by the wire transducer.

Figure 2.3: Set-up of the laser measurements.

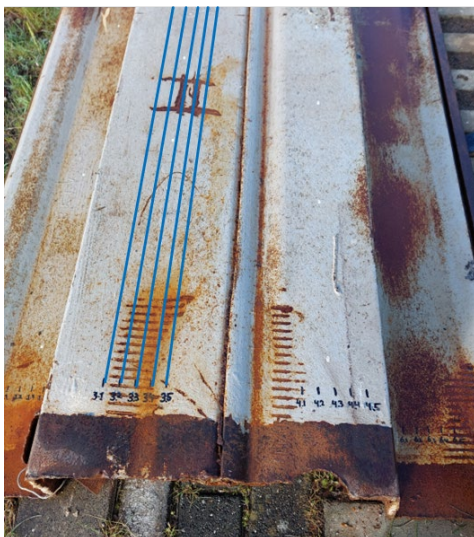
The laser measurements were carried out in the longitudinal direction of the sheet piling along 5 measurement lines on each web and flange with spacing of 2 cm in the transverse direction, as shown in Figure 2.4. A measurement of the residual thickness was performed every millimetre.

Figure 2.4: Measurement lines (laser measurements).

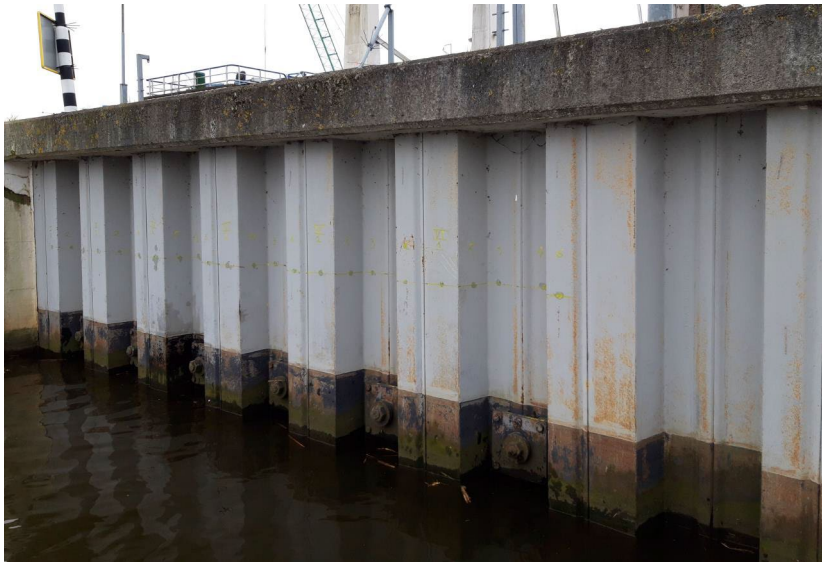
The in-situ PECT measurements were performed in the middle of each flange and web, starting from a reference point 1 m above the waterline. This reference point has been marked on each element of the sheet pile profiles by a yellow circle, as shown in [Figure 2.5](#) around the mid-height of the light grey area of the sheet piles above the waterline. The sheet piles were not cleaned before performing the measurements.

**Figure 2.5:** Reference points [2].

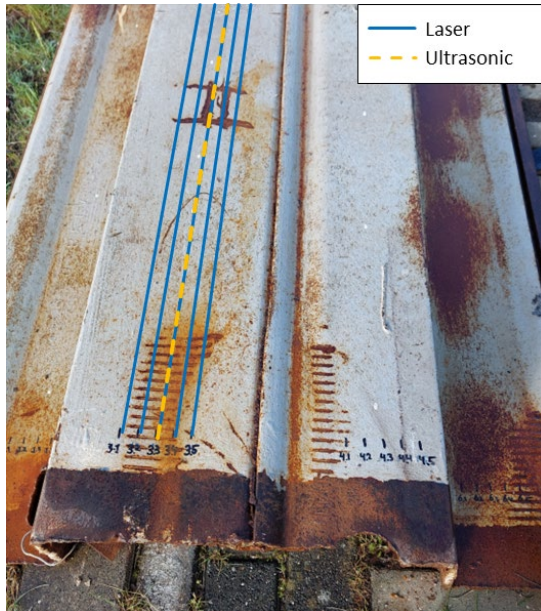
Ultrasonic measurements were carried out by TNO in the laboratory only. These measurements have been performed approximately every millimetre in the middle of each flange and web (it corresponds to the measurement line in the middle shown in [Figure 2.7](#)).

**Figure 2.7:** Measurement lines (ultrasonic measurements).

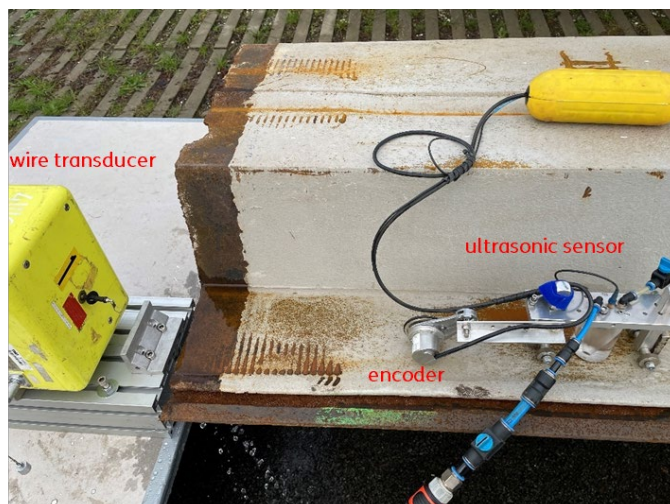
The measurement device is shown in [Figure 2.8](#) and consists of three parts: the ultrasonic sensor, the encoder and a wire transducer. The ultrasonic sensor is an Olympus V312 with a focal distance of 25.4 mm and it is placed in a plexiglas cover into which water is injected. The ultrasonic sensor is mounted on a trolley with an encoder that triggers a measurement approximately every millimetre. The trolley is manually moved over the sheet piling. Upon triggering of the data acquisition system, an ultrasonic measurement is taken and the signal of the wire transducer is read to measure the absolute distance of the measurement point to the top of the sheet pile profile.

**Figure 2.8:** Measurement set-up (ultrasonic measurements).

The ultrasonic sensor has not been calibrated against reference calibration blocks, due to the unavailability of specimens of the steel with properties similar to those of the inspected sheet pile profiles. Therefore, the residual thickness has been estimated based on an assumed sound velocity of 5950 m/s in steel.

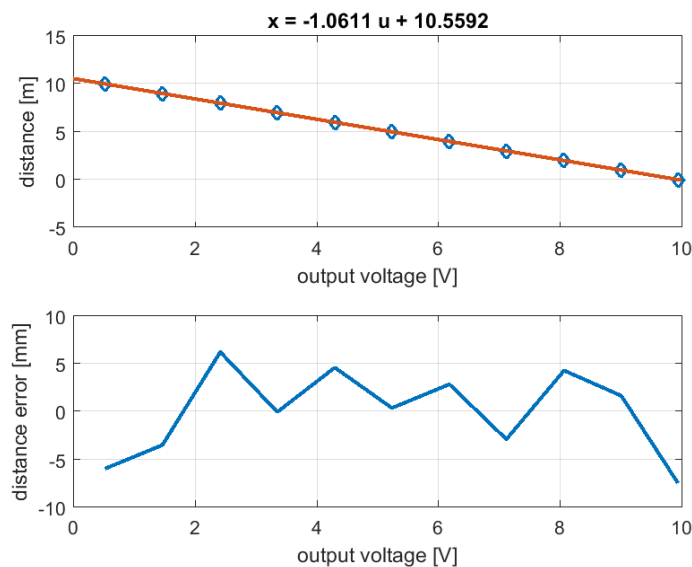
The wire transducer is calibrated prior to the measurements. The measured electrical voltage at the output of the wire transducer is converted into a distance measurement via a linear relationship, as shown in [Figure 2.9](#).

**Figure 2.9:** Calibration of wire transducer. Note the difference in scale of the top figure (m) and bottom figure (mm).

Due to non-linearities, there is an uncertainty in the measured distance in the longitudinal direction of  $\pm 5 \text{ mm}$ . The same uncertainty is estimated for the position in the transverse direction.

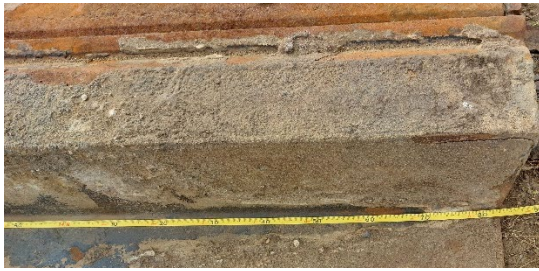
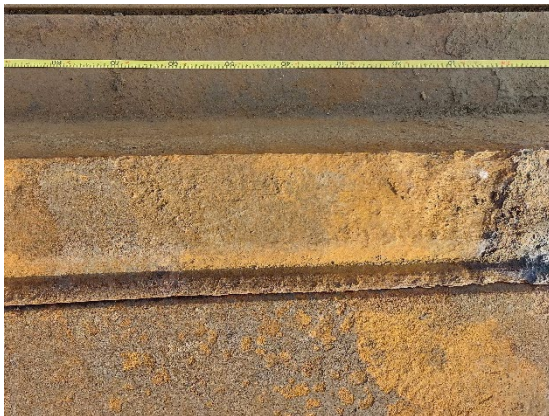
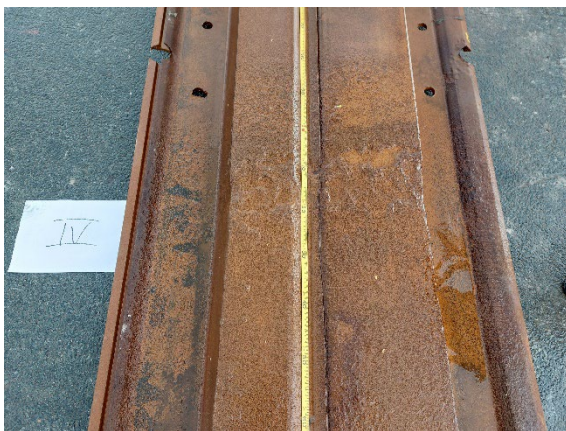
a) cleaning by the contractor with high pressure water jetting.

b) by TNO with high pressure water jetting.

c) by Straalbedrijf Schep by means of sandblasting.

**Figure 2.10:** Steel surface after cleaning of the sheet pile profiles.

- › by the contractor, with high pressure water jetting, after pulling out the profiles
- › by TNO, with high pressure water jetting
- › by Straalbedrijf Schep by means of sandblasting.

The results of the three cleaning steps is shown in [Figure 2.10](#).

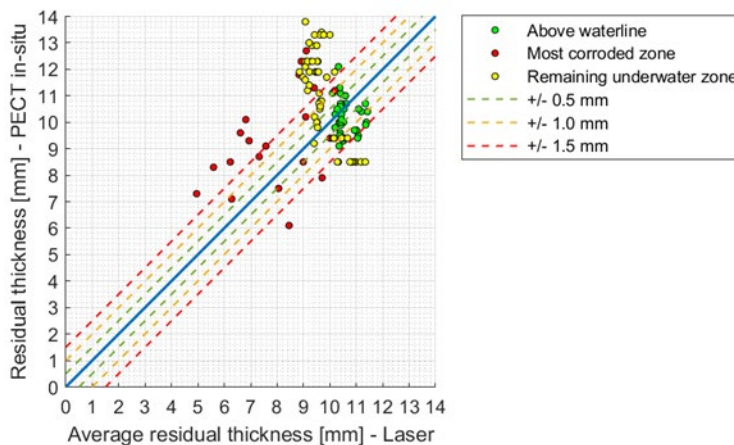
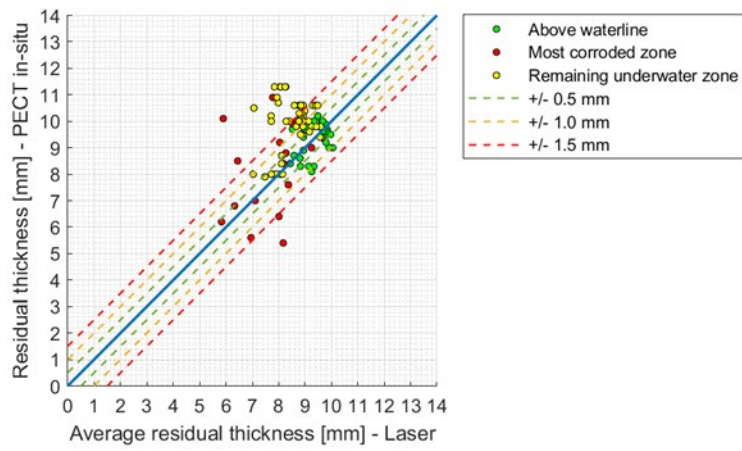
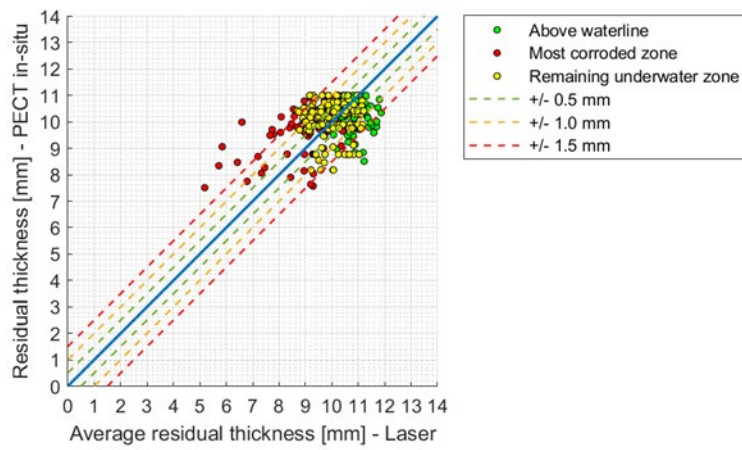
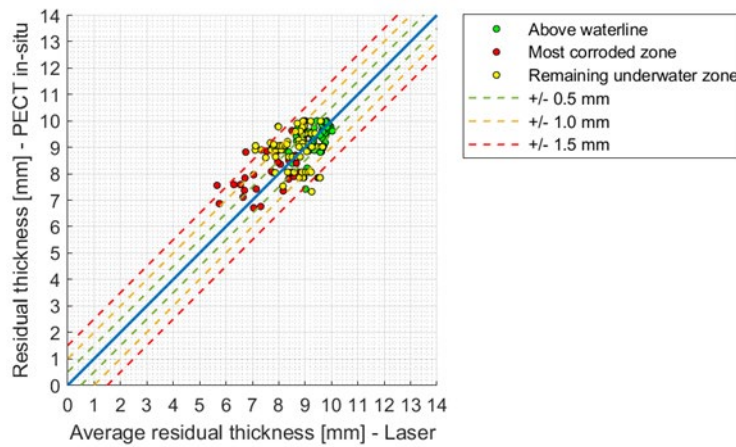
The PECT measurements are compared with the laser ones in the figures below. Since the comparison between the companies is not of interest for this study, they are referred to as “inspection company A” and “inspection company B” in the following. The PECT value of the residual thickness at a given measurement point is the average residual thickness over the footprint area, which includes the probe area and the lift-off of the probe from the steel surface [2, 3]. Therefore, the average residual thickness based on the laser measurements given on the horizontal axis is computed on the same footprint area.

Figure 4.1: Measurement errors – flanges (inspection company A).

Figure 4.2: Measurement errors – webs (inspection company A).

Figure 4.3: Measurement errors – flanges (inspection company B).

Figure 4.4: Measurement errors – webs (inspection company B).

It can be observed in Figure 4.1 and Figure 4.2 that, for some measurement points in the remaining under water zone, PECT overestimates the true residual thickness of the profiles. As discussed in [2], these deviations arise from the drifting of the measurement set-up used in situ.

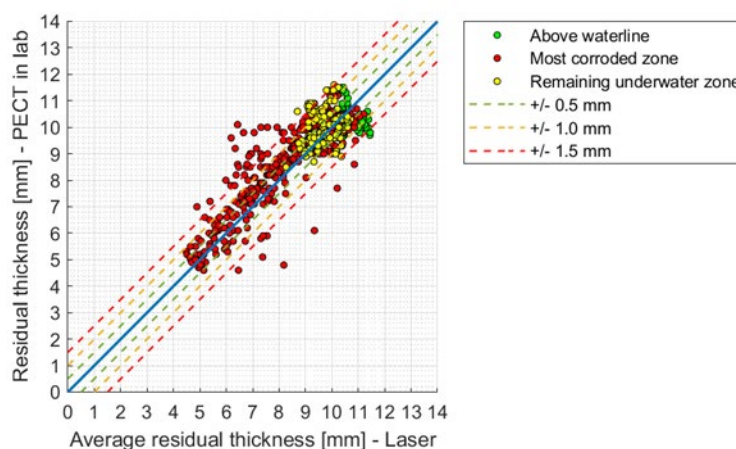
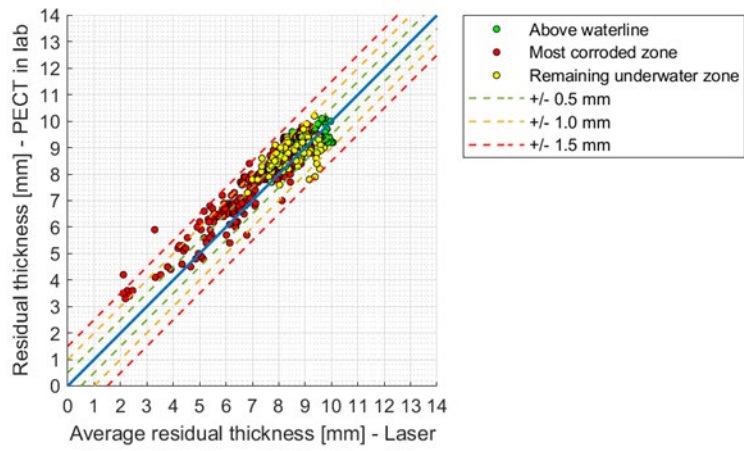
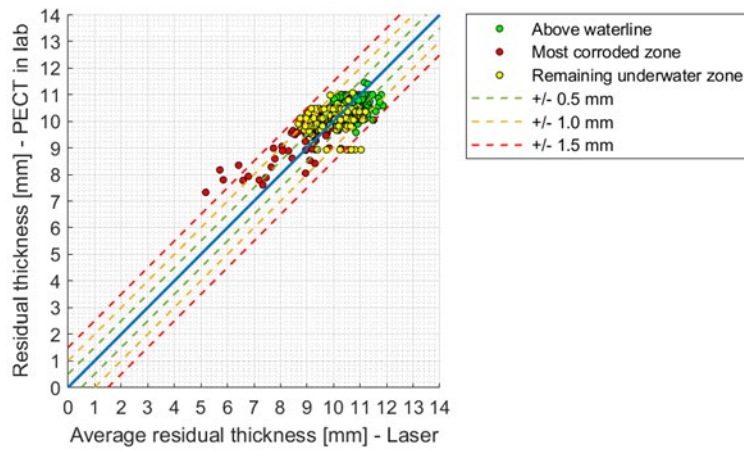
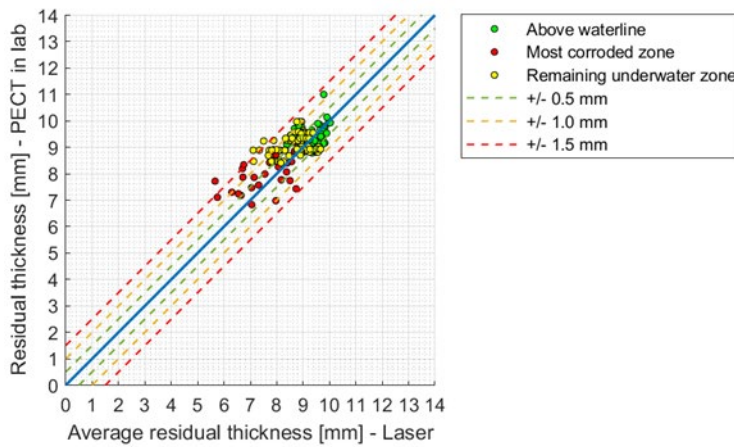
The PECT measurements performed by SGS and RPS are compared with the laser ones in the figures below.

Figure 4.5: Measurement errors – flanges (inspection company A).

Figure 4.6: Measurement errors – webs (inspection company A).

Figure 4.7: Measurement errors – flanges (inspection company B).

Figure 4.8: Measurement errors – webs (inspection company B).

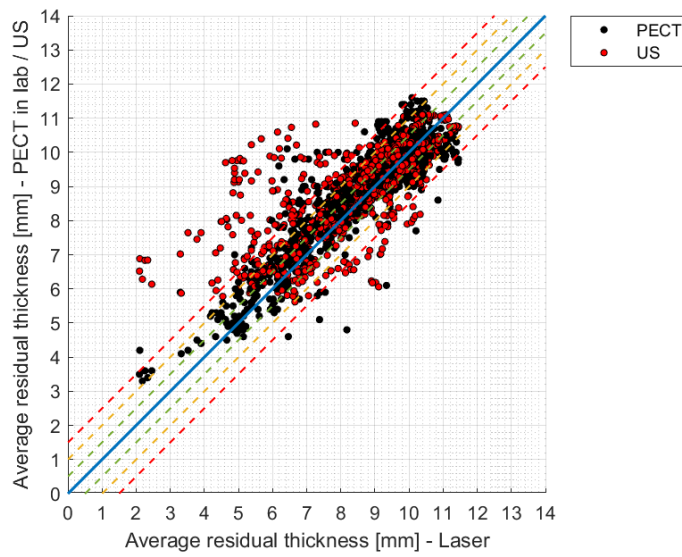
A further comparison is performed between the PECT measurements and the ultrasonic measurements, both performed in the laboratory. For each measurement point used by SGS in the laboratory, the average residual thickness has been determined based on the laser and ultrasonic measurements on the footprint of the PECT probe. The deviation of the ultrasonic measurements is remarkable and occurs in most of the corroded zone of the sheet pile sections.

Figure 4.9: Comparison between PECT and ultrasonic measurements.

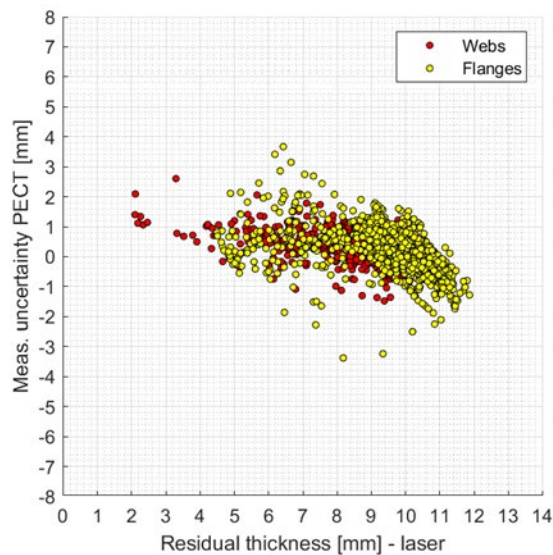
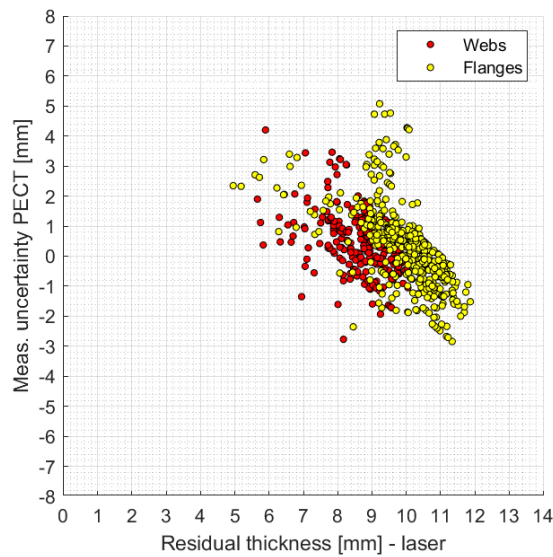
The observations of the measurement uncertainty as a function of the laser value of the residual thickness are shown in the figures below for the measurements in the laboratory and in situ.

Figure 4.10: Measurement uncertainty based on measurements performed in the laboratory.

Figure 4.11: Measurement uncertainty based on in-situ measurements.

A Normal distribution has been fitted to the two datasets separately. The mean value and standard deviation are listed in Table 4.1.

The positive mean value means that, on average, PECT overestimates the true thickness of the sheet pile profiles. This suggests that the calibration of this measurement technique should be performed to obtain unbiased estimates of the residual thickness. As expected, the standard deviation of the measurement uncertainty is higher in-situ than in laboratory conditions. Therefore, the lessons learned in this measurement campaign should be used to improve the measurement set-up used in the field [2, 3].

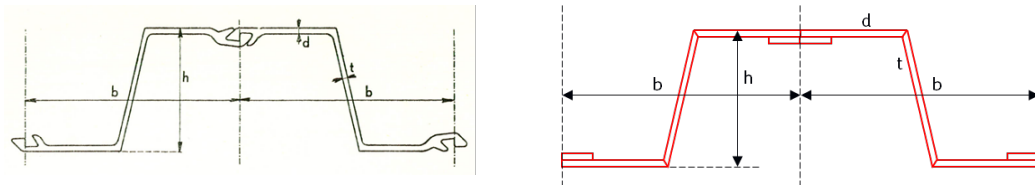
**Figure 4.12:** Simplified geometrical model of the cross-section. Left: actual geometry, right: simplified geometry.

- ) the webs and flanges are modelled by parallelograms
- ) interlocks are modelled by rectangular shapes, with height equal to the thickness of the flanges, while the base is calibrated to match the elastic section modulus  $W_{el}$  of the uncorroded Belval II R profile
- ) corrosion is considered only on the water side.
